Home Tune-uP Report

JRV Home Inspection Services, LLC

10/10/2008

Inspection ID:	2755
Structure type:	Detached
Date built (est.):	1968
# of bedrooms:	3
House size (sq. ft.):	2074
House volume (cu. ft.):	16633
Heating fuel:	Heating Oil
Price of heating fuel:	\$4.009/Gallon
Price of electricity:	\$0.179/kWh

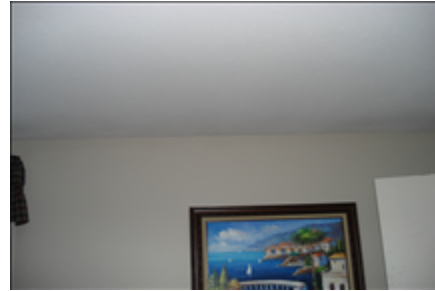
1 - 4. These two IR images show air leakage through the soffit area affecting the ceilings. These images are representative of most of the second floor ceilings along the soffits. Gaps were found on the exterior which would likely be the source of the air. See photo #4 in the next section.

- Recommend the above discussed deficiencies be evaluated for correction by the appropriately qualified specialists.

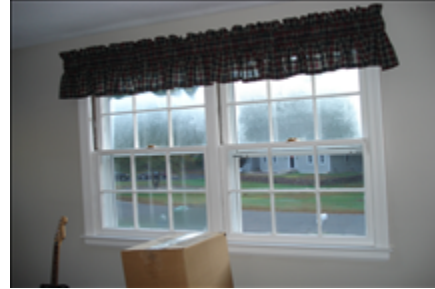
5 & 6. This images illustrates the effectiveness of a storm window. The left window has a storm in place while the right does not. The temperature differential from the left to the right is 10 - 14 degrees. Also of note is the much increased air leakage and resulting cooling seen at the bottom of the right window.

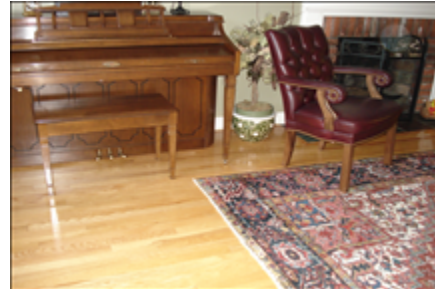
7 & 8. This image of the floor over the boiler shows a great amount of warmth penetrating from the basement below. This is significant for two reasons;

1. It demonstrates the lack of good insulation en-casing the boiler. It is also indicative of an older less efficient system.
2. The lack of insulation in the floor.

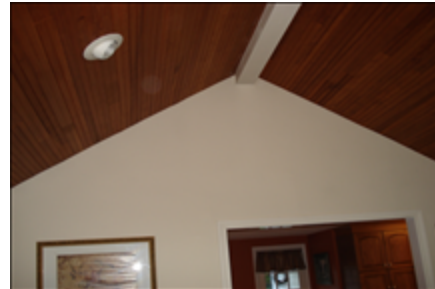
9 & 10. Significant air leakage can be seen in this image of the addition wall and vaulted ceiling. This is a very typical pattern seen with fiberglass batt insulation with a paper type vapor barrier.

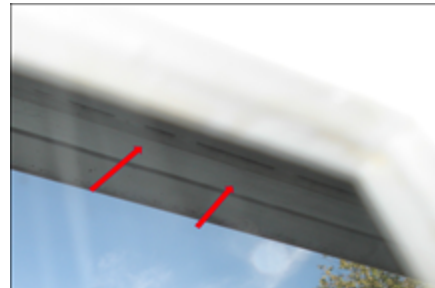
4. Soffit Gaps

4. The arrows are indicating gaps in the soffit board that is contributing to air infiltration seen in the IR images in the previous section.

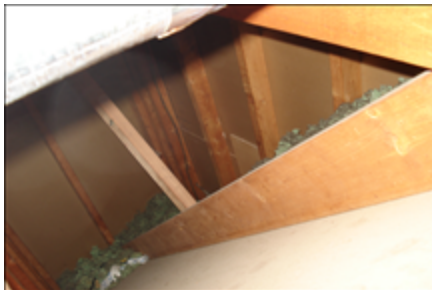
Uninsulated Attic Gap

House Attic: The photo shows the uninsulated stairway opening viewed from the attic. The walls and much of the sloped ceiling are completely void of insulation. Recommend an insulation or other appropriately qualified specialist rectify this deficiency.

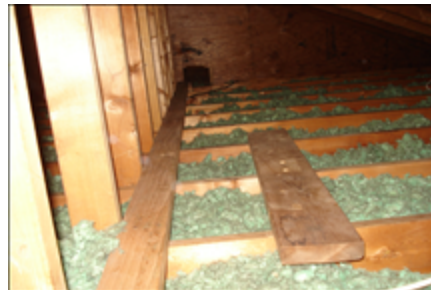
Kitchen Attic

Kitchen Attic: The access door to this area located in the garage should be closed unless in use. The access panel should be of a fire rated material. Also noted was the absence of attic vents. Ventilation is important in order dissipate excessive heat and moisture. Recommend that these deficiencies be rectified by the appropriately qualified specialists.

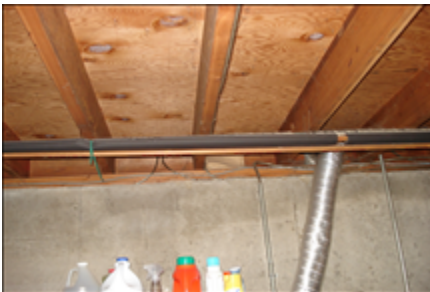
Uninsulated floor

- It is most important to insulate the rim joists even if the basement is to become conditioned space.

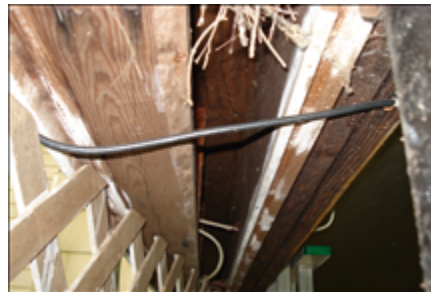
Addition: A large uninsulated gap (see photo) along the entire perimeter was found under the structure. The underside of fireplace bump out was also uninsulated. Recommend these area be insulated by an insulation specialist.

Underside of Addition, Uninsulated Gap

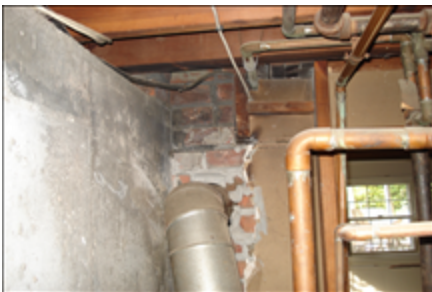
- Running the ceiling fan will improve warm (and/or cool) air circulation, increasing the comfort of your home and allowing you to lower (or raise) the thermostat temperature.
- Flue pipe entry into chimney is not sealed. Have heating specialist correct.

Unsealed Flue Pipe Entry
